Manhole Inspection Summary

Manhole # S47E__002MH

Insp Date: **7/29/08 10:28 AM**

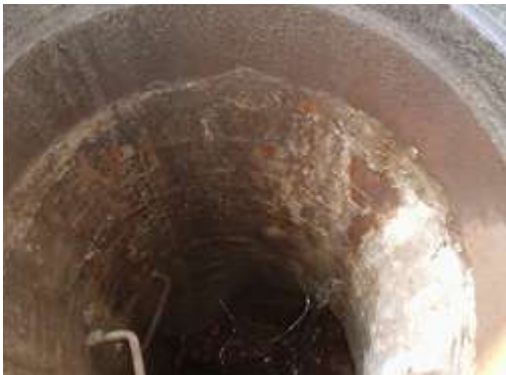
Defect 2

infiltration

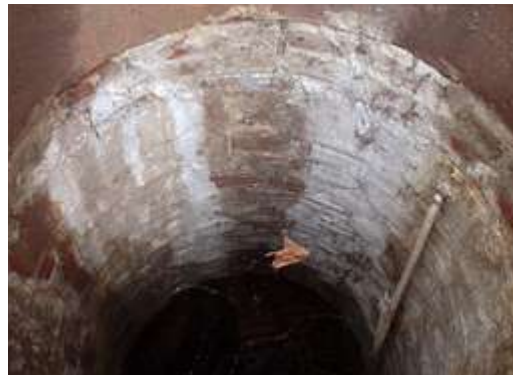
Defect 1

frame leaks

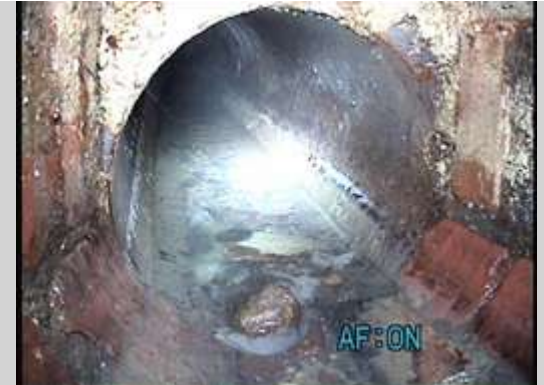
12 O'Clock Outflow

8 in. Circular Gravity Sewer
Pipe Out @ 12 O'Clock

Pipe Height: **8.4** (in.) Rod and Bar (Angled)
Pipe Material: **Clay** ☐ Pipe Lined
Invert Depth: **10.80** (ft.) Flow Characteristics: **Slow**
Deposits: ☒ None ☐ Mud ☐ Sludge ☐ Debris ☐ Grease
Silt Depth: (in.) Deposits Extent:
Infiltration: **None** Pipe Seal Cond: **Sound**

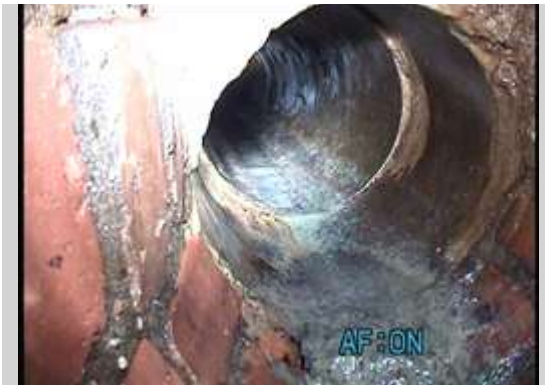
3 O'Clock Inflow

8 in. Circular Gravity Sewer
Pipe In @ 3 O'Clock

Pipe Height: **8.4** (in.) Rod and Bar (Angled)
Pipe Material: **Clay** ☐ Pipe Lined
Invert Depth: **10.25** (ft.) Flow Characteristics: **Slow**
Deposits: ☒ None ☐ Mud ☐ Sludge ☐ Debris ☐ Grease
Silt Depth: (in.) Deposits Extent:
Infiltration: **None** Pipe Seal Cond: **Sound**

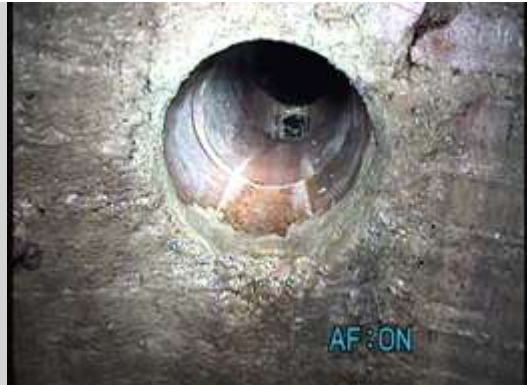
9 O'Clock Inflow

Pipe In @ 9 O'Clock

Pipe Height: **8.4** (in.) Rod and Bar (Angled)

Infiltration: **None** Pipe Seal Cond: **Sound**

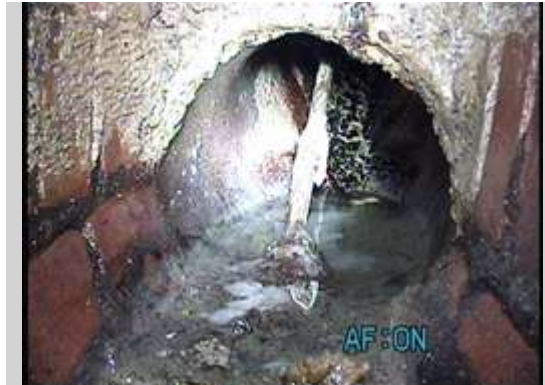
Drop In @ 9 O'Clock

Drop: **Inside**

Drop Condition: **Open**
